The Ruined Church of St Martin

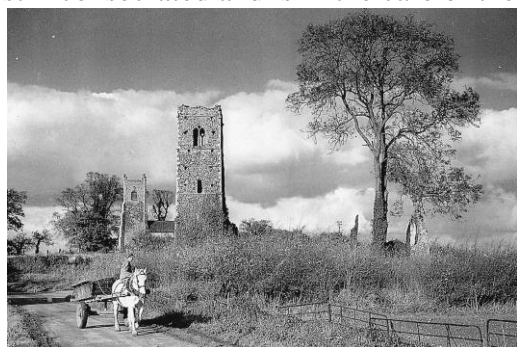
Figure 1 A view of the ruins in 1959 (Jimmy Hazel)

Since the 1950's ivy took hold of the masonry and elm suckers and scrub began to take root in the churchyard as well as the nave. This hid just how much of the ruin remained and how much damage was taking place beneath the undergrowth. The large tree you see in *figure 1* fell through into the Chancel demolishing whole sections of the flint wall

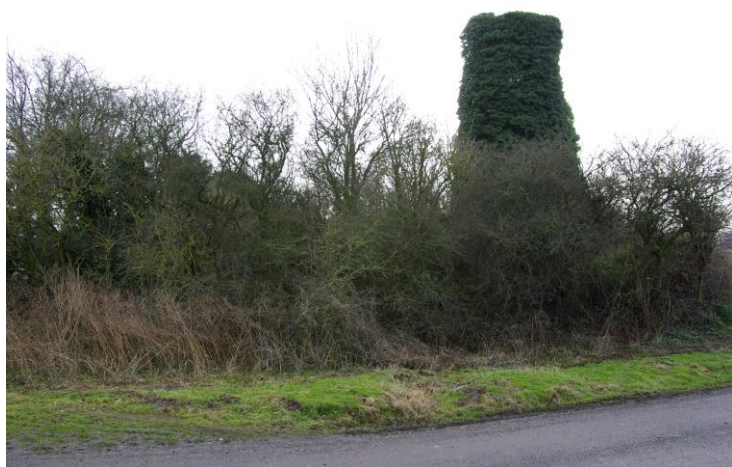
Figure 2 View of overgrown ruin in 2009 (Photo Mike Fenn).

Work started on the consolidation of these ruins in 2009 by which time the whole structure was covered with ivy and almost impenetrable brambles, nettles and scrub. Some trees had taken hold within the walls of the nave.

It is hard to visualise just how hidden the ruins were only 18 months ago. Left untended and neglected for many years, they surely would have collapsed as the saplings became larger and the tangled ivy sent roots into the loose core behind the facing flints. In time these roots would have loosened the wall itself and as individual flints fall away, rainwater washes away the “fill” and the whole structure becomes unstable and dangerous.

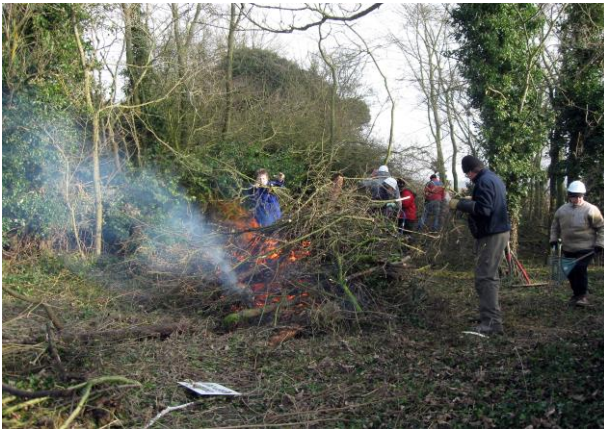
Fig 3 Volunteers clear away scrub and ivy (Mike Fenn)

The first task for the volunteers, working on behalf of the PCC, was to tackle this undergrowth. It was very hard work and took several months to complete, but finally, as autumn arrived, the ruins were exposed and the debris cleared away.

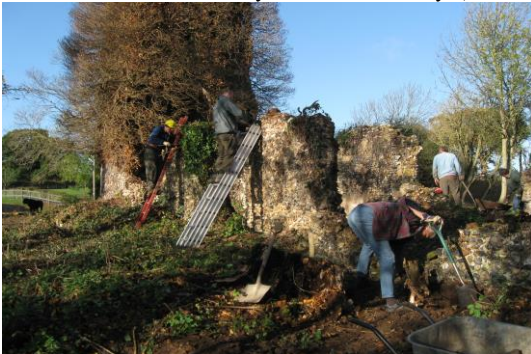
Fig 4 Volunteers clear away debris and roots from the remaining walls. (Mike Fenn)
